# Report of Investigation

Title of Investigation: Arthur Capper SR Apartments Fire SE WDC	Investigation Number: 768015-18-0045	Report Number: 6
--	---	---------------------

**Type of Exam:** ORIGIN and CAUSE REPORT

**Date of Incident:** September 19, 2018

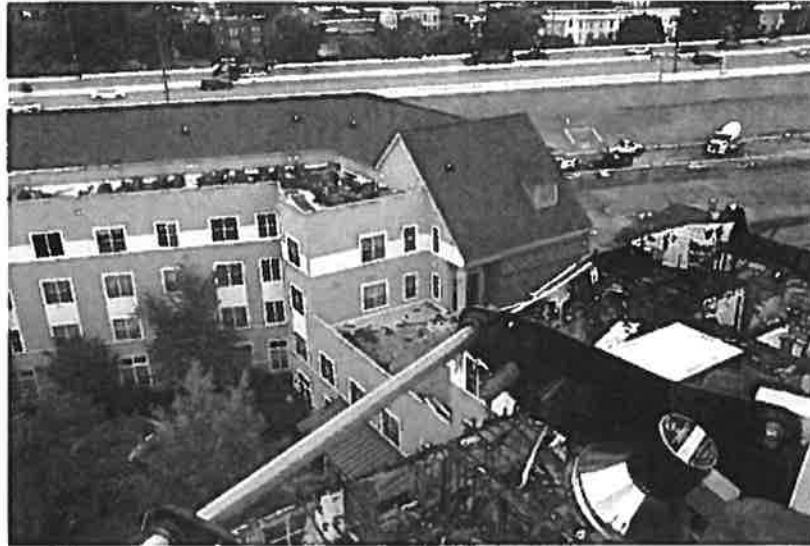
Undamaged Roof Section on "BC" Corner

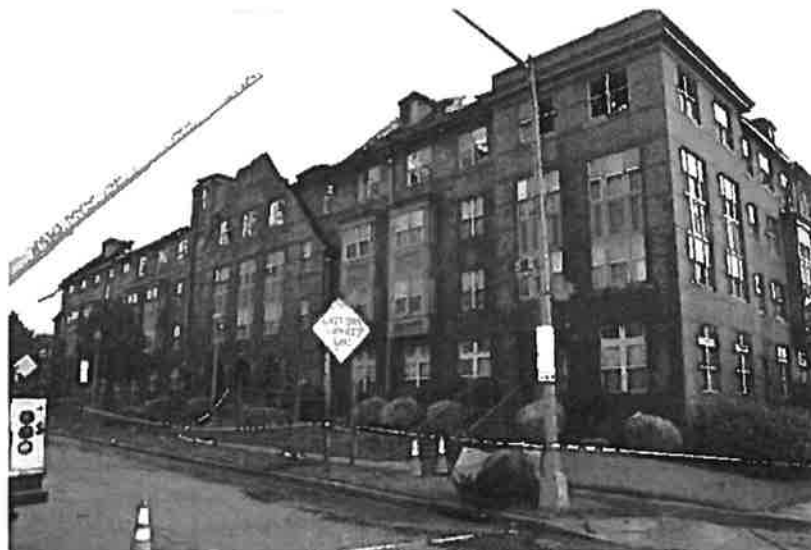
40. Side A – Side A was the most damaged side of the exterior. The roof on this side had collapsed into the interior of the structure and a portion of the exterior wall above the building's main entrance was listing toward the exterior requiring its removal. The windows on the fourth floor had been broken out during suppression operations. There was no observable fire damage on this side with the exception of some smoke deposits along the roofline.

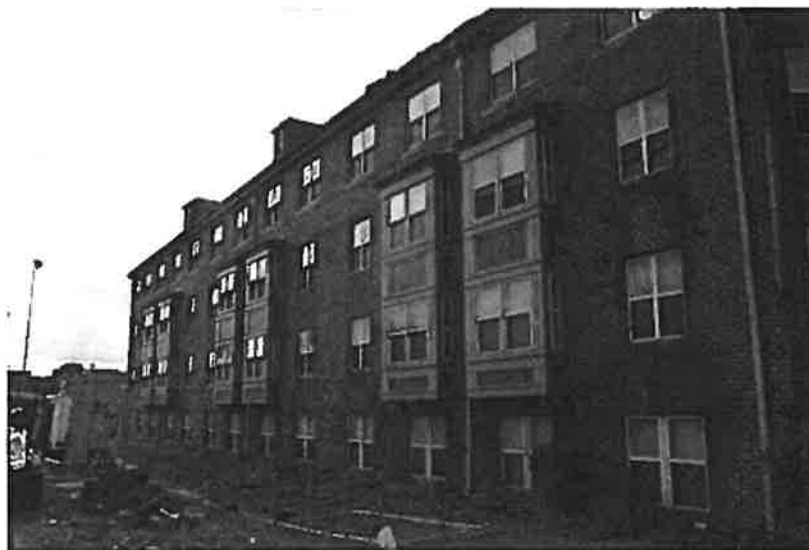
41. Side B – No observable fire damage existed on this side of the building. There were no smoke deposits on this side of the building. The damage that did exist was in the roof with large sections of it collapsed to the interior and on a down spot that separate from the building when a portion of the roof collapsed.

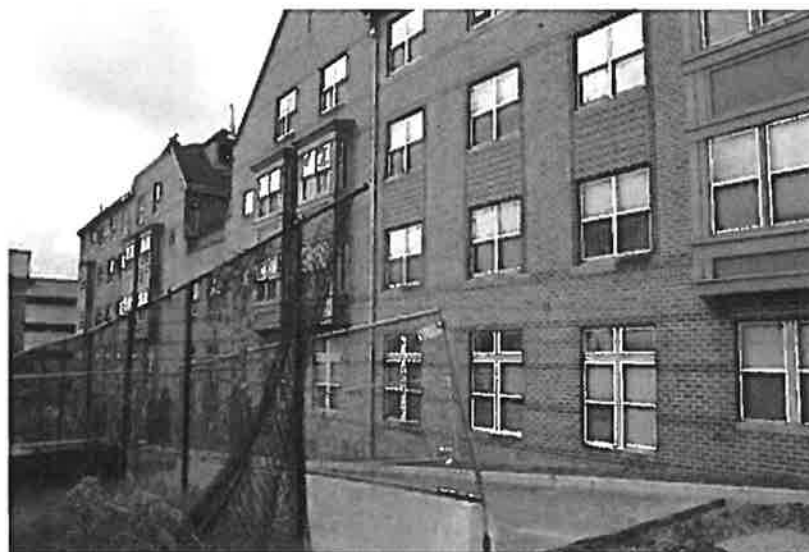
42. Side C – The damage on this side of the building was on the roof, with some collapse near the “CD” corner. There was no damage observed below the roofline.

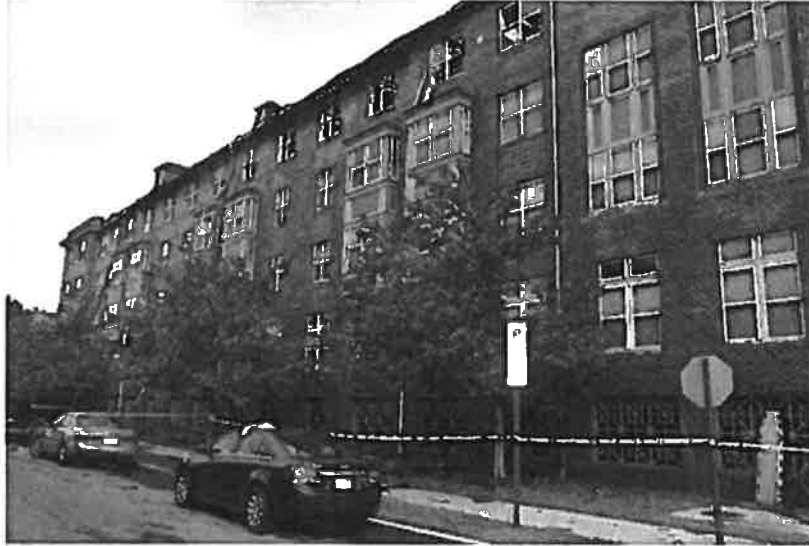
43. Side D – Large sections of the roof collapsed on this side causing the gutters to separate from the building in certain areas. The windows on the fourth floor had been broken out during suppression operations. Some smoke deposits were observed above some of these windows. The windows below the fourth floor were intact.

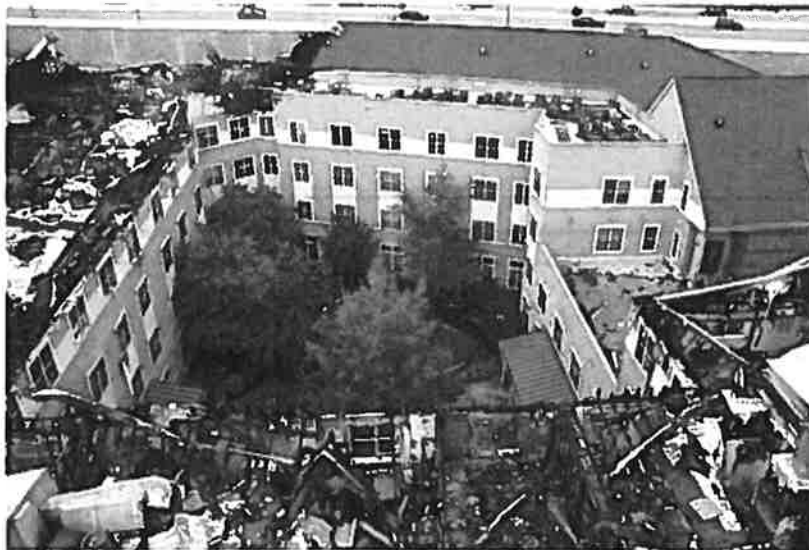
44. Roof – Three quarters of the roof had either been consumed in the fire or collapsed into the interior of the structure. The roof in the “BC” corner was the only section that was intact. Investigators observed the damage from the bucket of a Navy Fire Department Tower Truck. The fire damage observed was in the roof area only. The wood studs of the apartments below was largely undamaged by fire. This is consistent with the fire originating above the apartments.

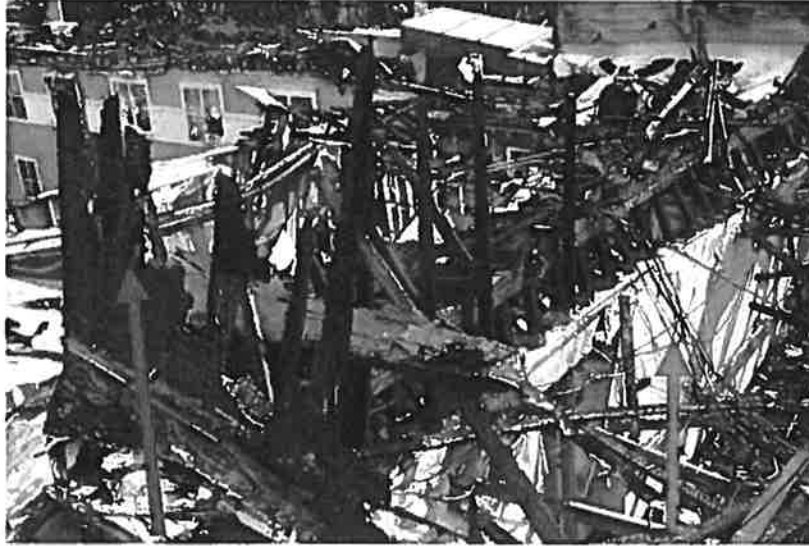
Fire Damage above the Roof Line & No Fire Damage Below

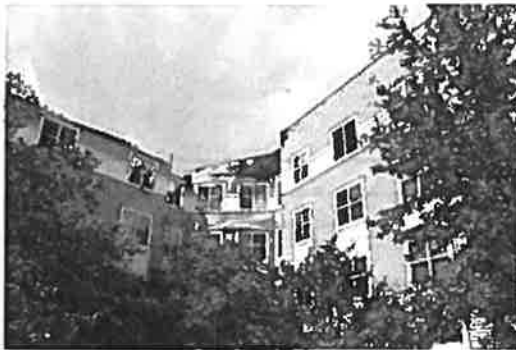
45. Courtyard – The interior courtyard had no fire damage below the fourth floor. Where fire damage was observed, it was caused by burn through from sections of the roof collapsing and burning through the courtyard wall. Very little of the vinyl siding was damaged by heat or fire during this event which is consistent with the vast majority of the fire remaining in the roof above the roofline. Most of the damage that was observed in the courtyard was from collapse. A portion of the wall in the “CD” corner of the courtyard failed when the interior of the building collapsed into the first floor in this area.

Some Burn Through “AB” Corner

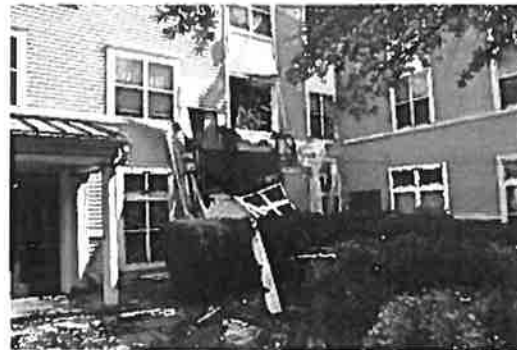
Damage from Collapse “CD” Corner

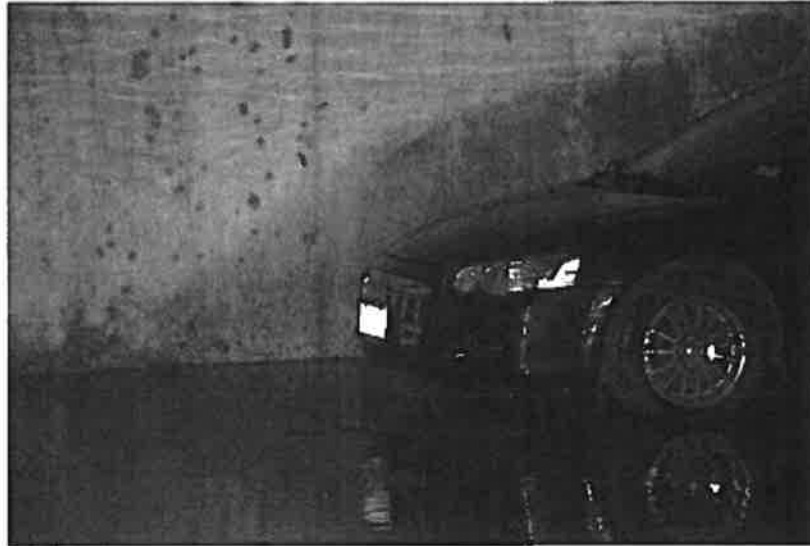
47. Basement – There was a large quantity of water in the basement from fire suppression activities above. This water damaged several vehicles and some equipment within the basement. There was no evidence of any fire damage in the basement.

Water in the Basement

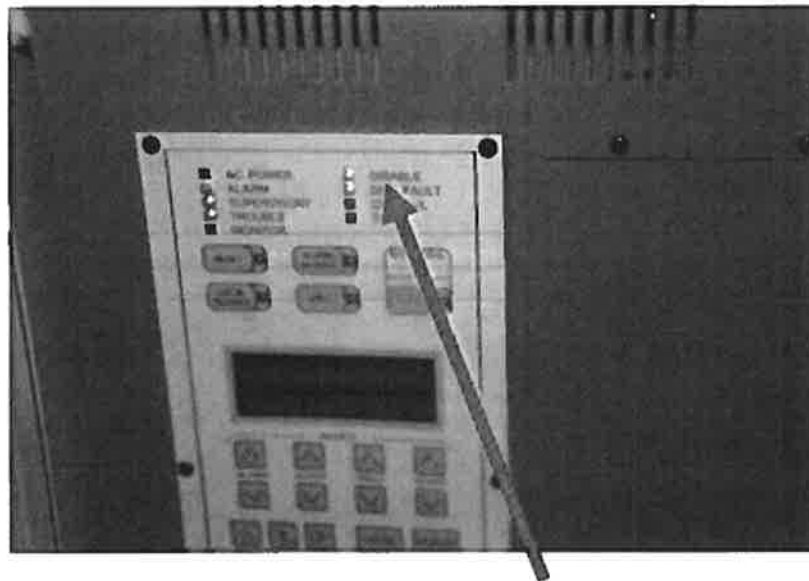
48. The fire alarm system was located in the basement. On the panel, the light labeled “Disable” was illuminated and the system was energized as of Thursday September 19, 2018. On that date, it was decided by the DCFD to leave the panel in place in order for it to be examined by representatives and forensic experts from the insurance industry. When investigators returned to the basement on September 23, the panel was no longer energized.

Alarm Panel with Disable Light Illuminated

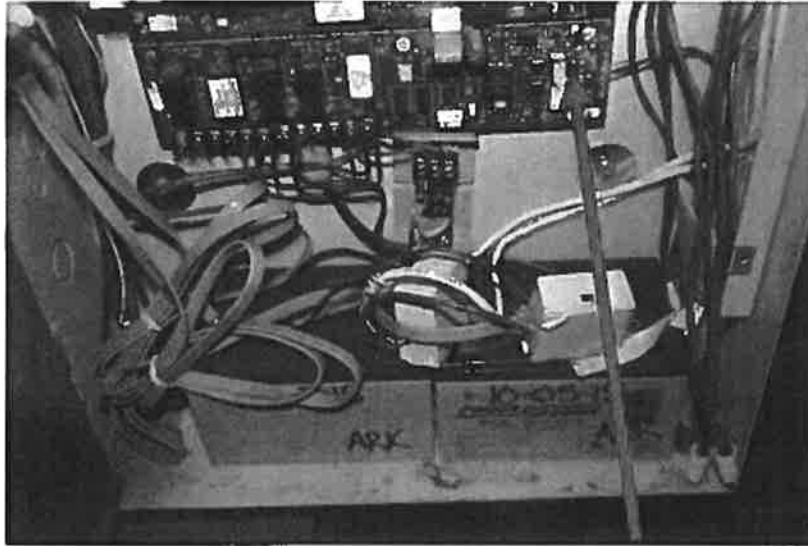
49. The inside of the panel revealed there was damage to a circuit of the panel. It was unclear whether this damage was caused by this event or pre-existed the fire event.

Blown Out Circuit inside the Fire Alarm Panel

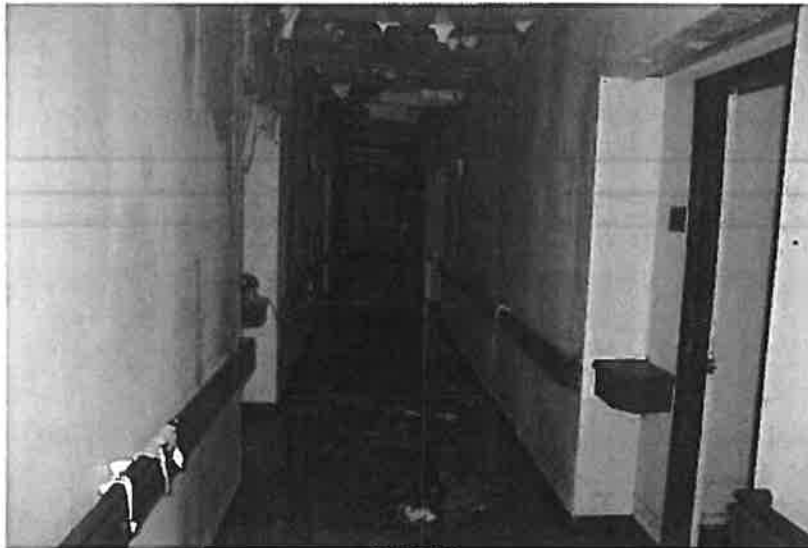
50. First Floor – This floor sustained no direct fire damage from this event. There was a significant amount of water on the floors and three areas of collapse along the inner rim of the building. These areas of collapse were along Side A, Side B and in the “CD” corner. In each area of collapse, investigators identified roofing material and portions of each of the floors above.

Water Damage on the First Floor

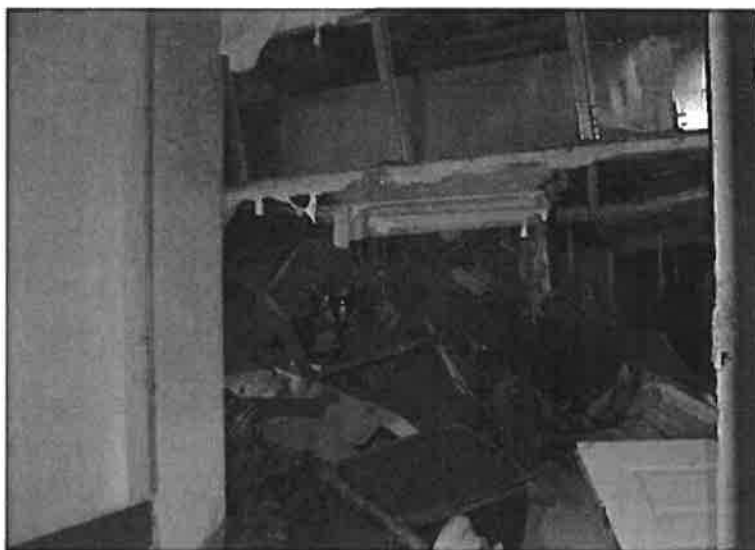
First Floor Collapse

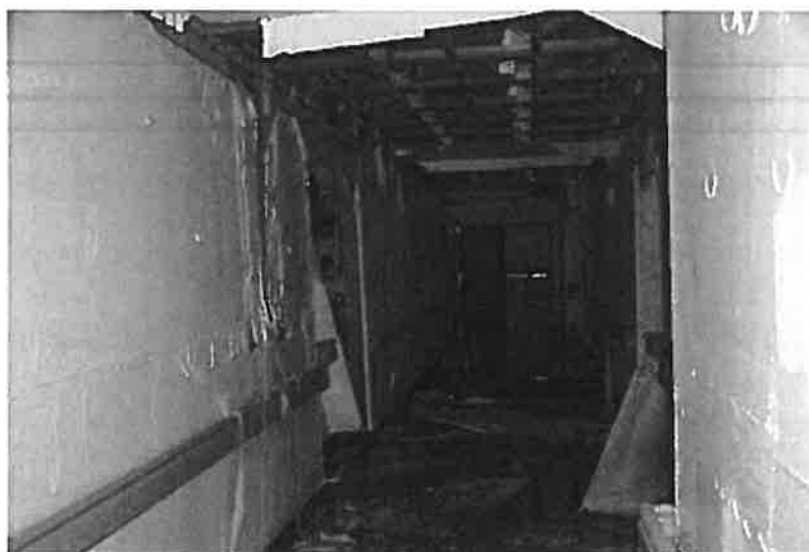
Collapse and Water Damage on the Second Floor

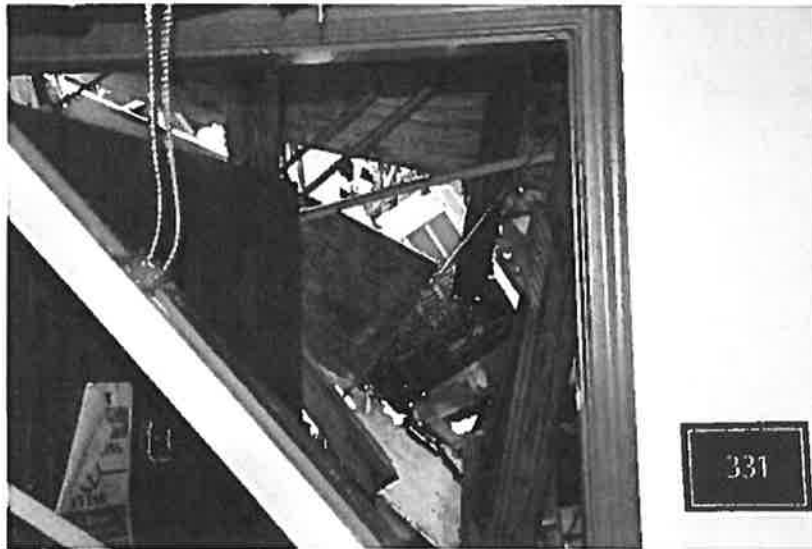
55. **Third Floor** – There was no direct fire damage on the third floor. The amount of water on the floor from fire suppression activities above was substantial. Investigators' attempts to walk this floor were unsuccessful and unsafe due to the excessive softening of the floors.
56. Collapse was present on this floor as well. Investigators were able to photograph inside Apartment 331, which sat directly below Apartment 431.

Collapse Down Through Apartment 331

58. The lack of any direct fire damage is consistent with the fire not originating on the third floor. The collapse down through Apartment 331 was the most damaged area of the floor and consistent with witness observations that the fire originated in the cockloft directly above this area. It should be noted that the collapse was caused by the large amount of water put into the building at this point rather than the collapse being cause by the fire itself.

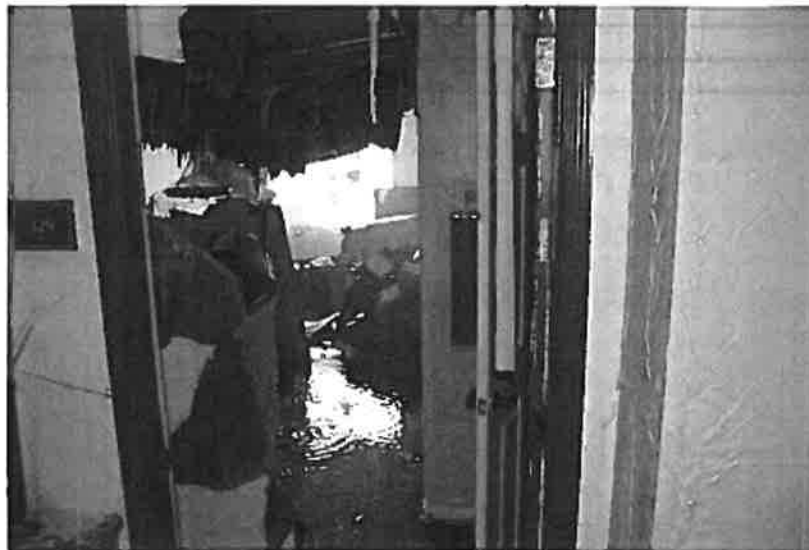
57. The neighboring Apartment 329 had some minor collapsing but significantly less than that of Apartment 331.

Collapse Down in Apartment 329

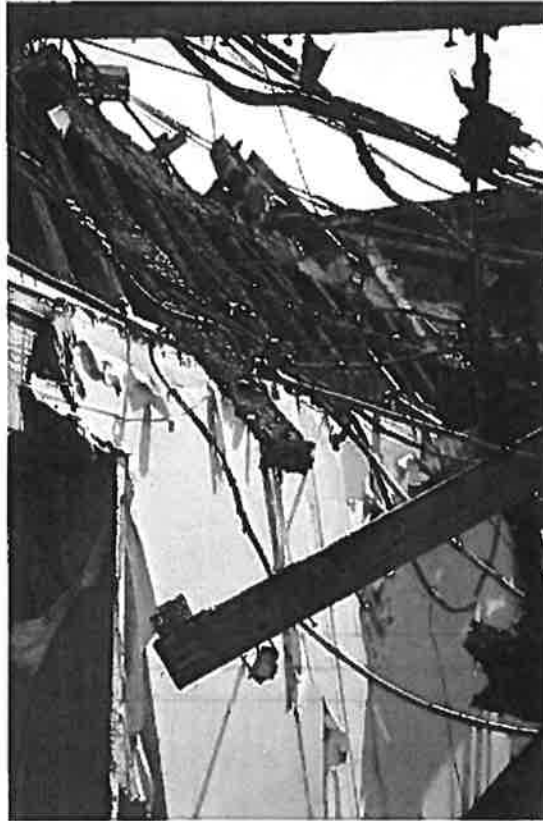
59. Fourth Floor – The fourth floor was damaged to the point that investigators could not make entry into the floor at all from the emergency staircase of Side A, as the risk of further collapse was too great. The direct fire damage observed was all above this floor. The lumber and wall covering of this floor were undamaged by fire. The damage to the lumber for the cockloft was badly charred and much of the asphalt roof covering this cockloft was consumed during the event. The most damage area of the cockloft was above Apartment 431.

Damage above Apartment 431

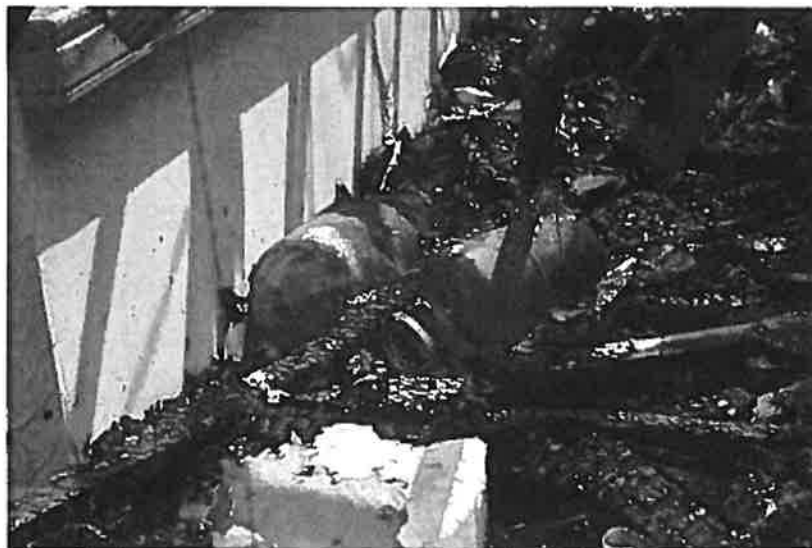
60. Firefighters stated that they believed they observed propane tanks on fire in this area of the building. Investigators uncovered no evidence of a propane tank in this area. A number of similar looking tanks used to hold Freon for air conditioning units were located. There is no evidence that a propane tank was involved in the ignition of this event.

Freon Tanks Damaged by Fire

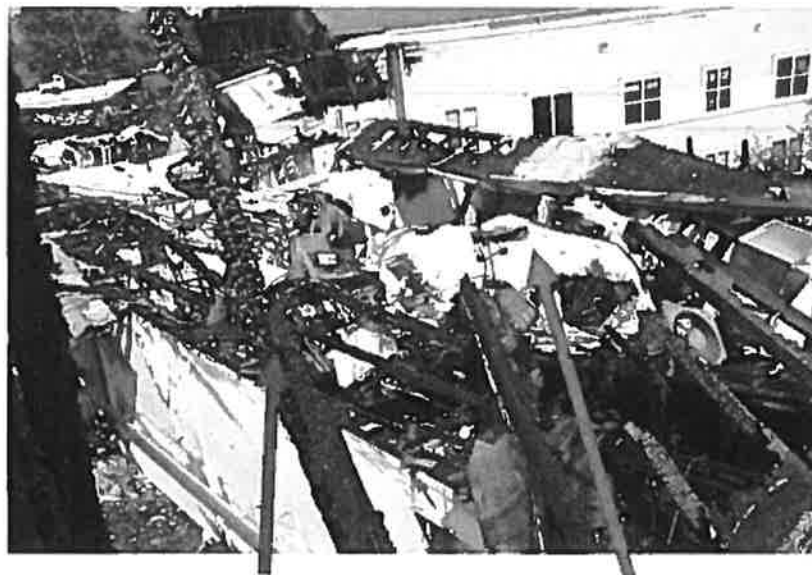
61. The damage observed on the fourth floor is consistent with a fire originating inside the cockloft above Apartment 431.
62. Attic Level – The damage to the Attic Level along Side A of the building was significant. The area around the emergency staircase had burned and collapsed to the fourth floor. The lumber for the cockloft was significantly charred and the roofing material was largely consumed. The roofing material on the inner flat section was in considerably better condition than the roof of the cockloft. This is consistent with the fire originating in the cockloft rather than on the flat section of roof.

Damage to the Cockloft vs. Damage to the Flat Section

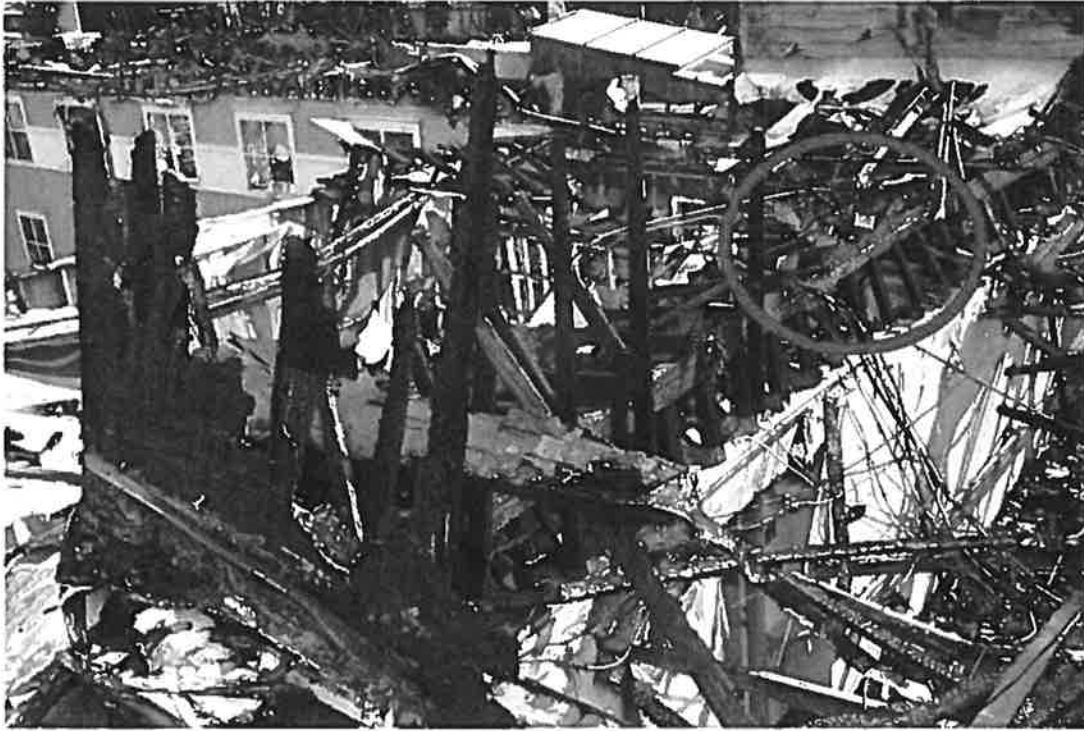
63. In the weeks after the fire, investigators, utilizing a crane were lowered into this area of the building and identified the area of origin as inside the cockloft directly above the kitchen for Apartment 431. Investigators

with the use of the crane removed Air Conditioning Compressors, electrical wiring, examined a bathroom ceiling fan, and light fixtures. These items were functioning as designed and did not cause this fire.

Area of Origin in the Cockloft above the Kitchen for Apartment 431

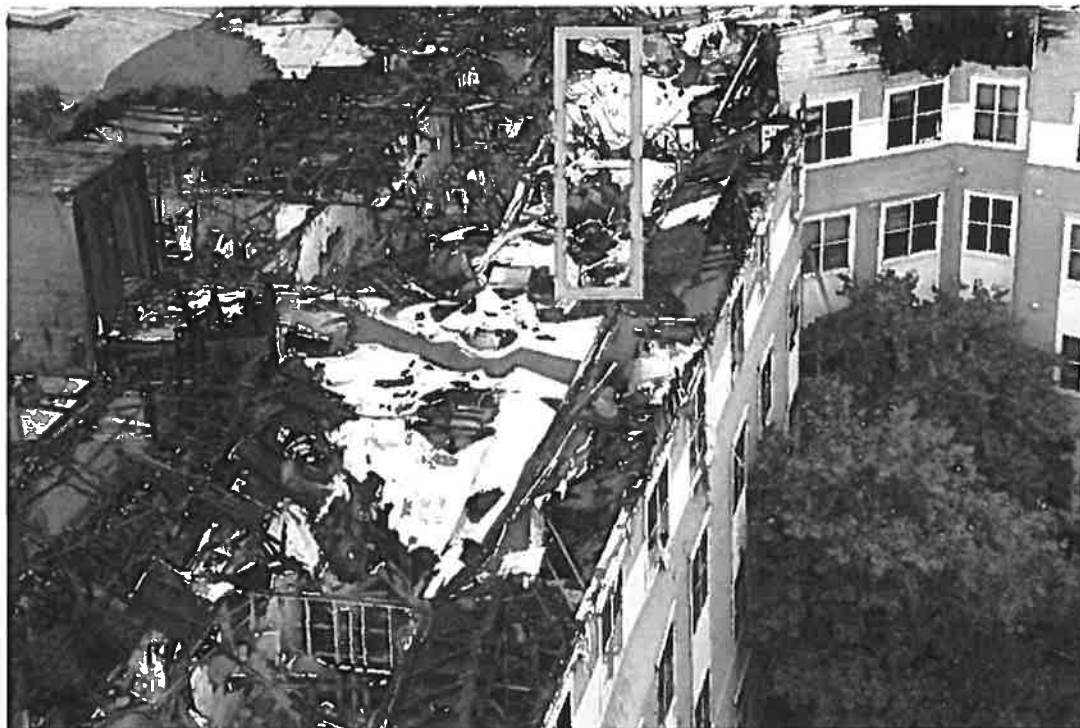
64. First arriving firefighters reported a garden hose pulled near where the fire originated. Investigators located a green garden hose extended toward the area of origin. The hose appears to have been pulled back towards its source as portions of the building collapsed. This is evidence that an unknown individual attempted to extinguish the fire in its early stages.

Garden Hose Pulled Towards Area of Origin
