Title of Investigation:  
Arthur Capper SR Apartments Fire SE WDC

Investigation Number:  
768015-18-0045

Statement of Certified Fire Investigator

Type of Exam: ORIGIN and CAUSE REPORT

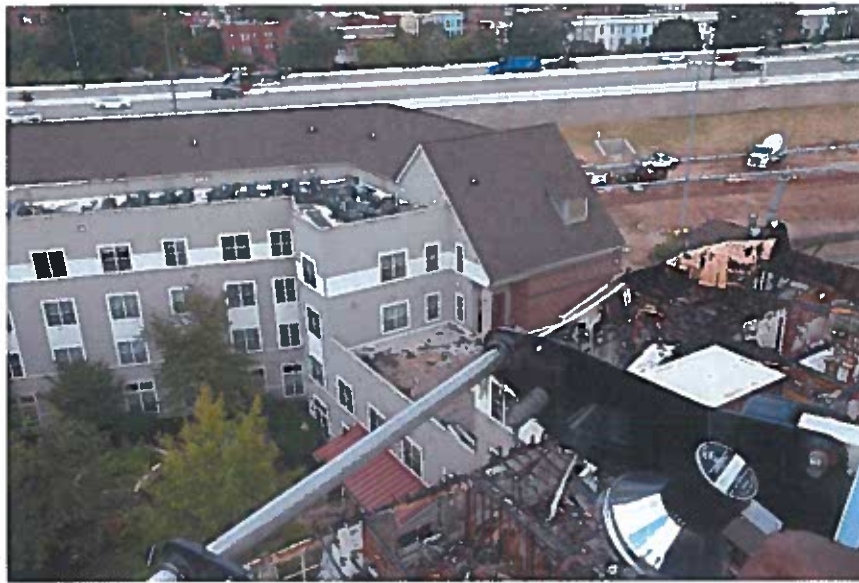
Undamaged Roof Section on “BC” Corner

44. Roof – Three quarters of the roof had either been consumed in the fire or collapsed into the interior of the structure. The roof in the “BC” corner was the only section that was intact. Investigators observed the damage from the bucket of a Navy Fire Department Tower Truck. The fire damage observed was in the roof area only. The wood studs of the apartments below was largely undamaged by fire. This is consistent with the fire originating above the apartments.

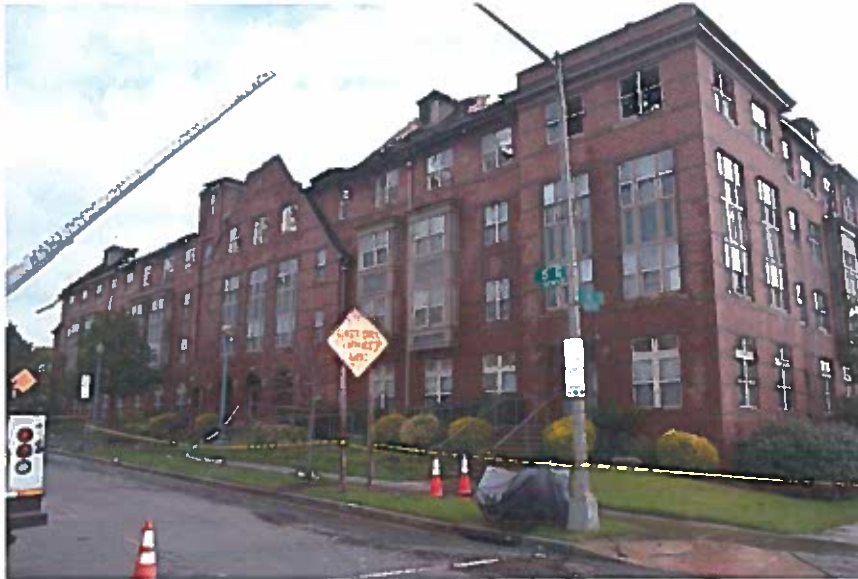
40. Side A – Side A was the most damaged side of the exterior. The roof on this side had collapsed into the interior of the structure and a portion of the exterior wall above the building's main entrance was listing toward the exterior requiring its removal. The windows on the fourth floor had been broken out during suppression operations. There was no observable fire damage on this side with the exception of some smoke deposits along the roofline.

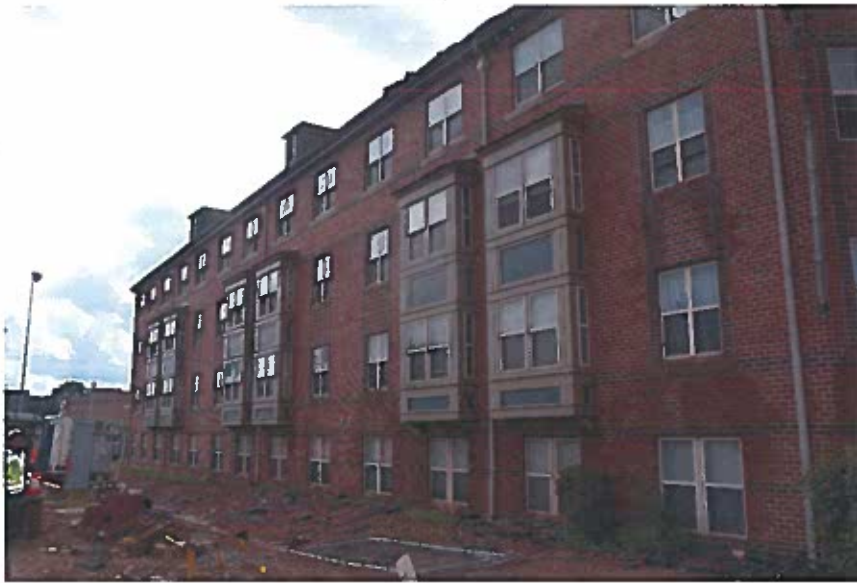
41. Side B – No observable fire damage existed on this side of the building. There were no smoke deposits on this side of the building. The damage that did exist was in the roof with large sections of it collapsed to the interior and on a down spot that separate from the building when a portion of the roof collapsed.

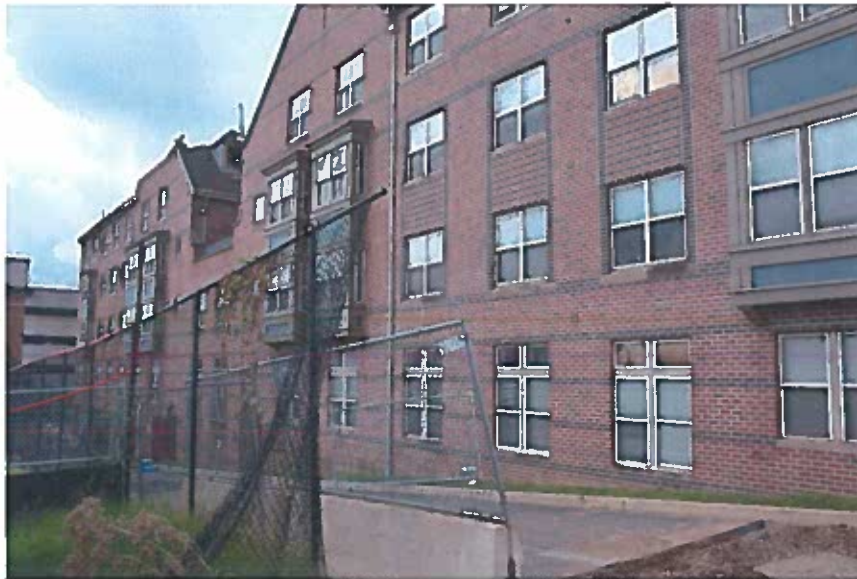
42. Side C – The damage on this side of the building was on the roof, with some collapse near the “CD” corner. There was no damage observed below the roofline.

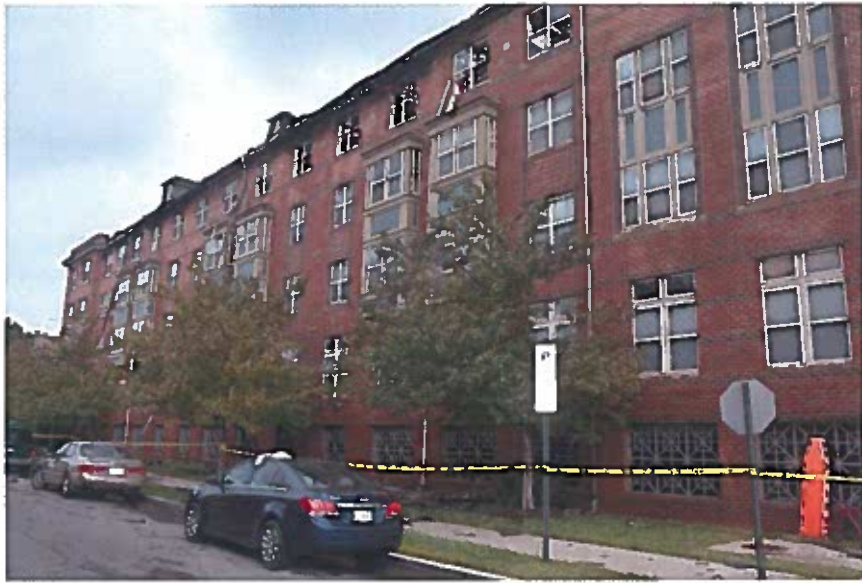
43. Side D – Large sections of the roof collapsed on this side causing the gutters to separate from the building in certain areas. The windows on the fourth floor had been broken out during suppression operations. Some smoke deposits were observed above some of these windows. The windows below the fourth floor were intact.

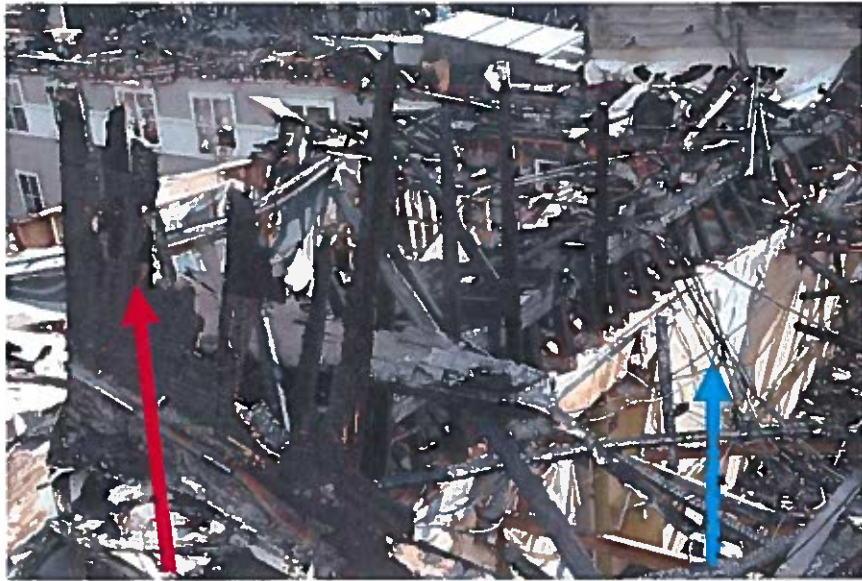
Fire Damage above the Roof Line & No Fire Damage Below

46. The damage observed on the exterior of the structure is consistent with a fire originating in the roof area and spreading across the roof. No significant fire damage was observed below the roofline.

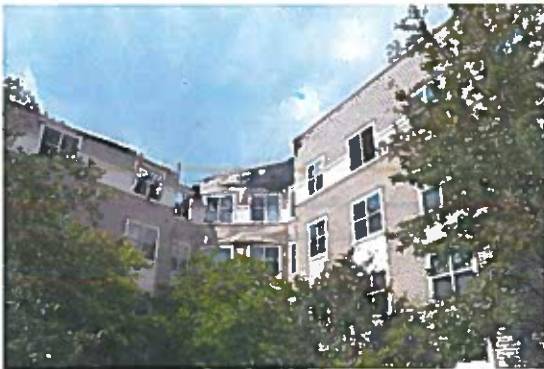
45. Courtyard – The interior courtyard had no fire damage below the fourth floor. Where fire damage was observed, it was caused by burn through from sections of the roof collapsing and burning through the courtyard wall. Very little of the vinyl siding was damaged by heat or fire during this event which is consistent with the vast majority of the fire remaining in the roof above the roofline. Most of the damage that was observed in the courtyard was from collapse. A portion of the wall in the “CD” corner of the courtyard failed when the interior of the building collapsed into the first floor in this area.

Some Burn Through “AB” Corner

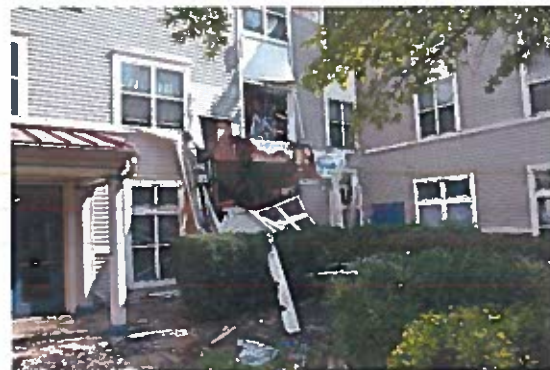
Damage from Collapse “CD” Corner

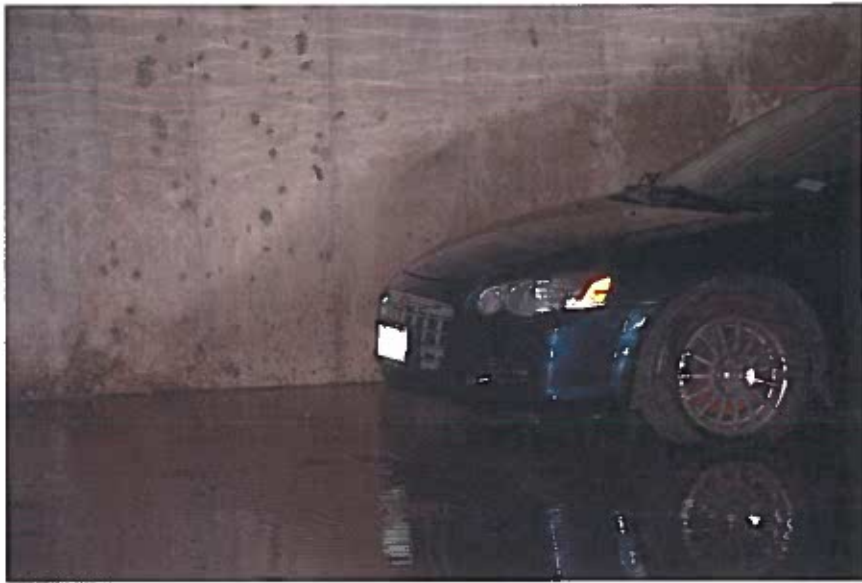
47. Basement – There was a large quantity of water in the basement from fire suppression activities above. This water damaged several vehicles and some equipment within the basement. There was no evidence of any fire damage in the basement.

Water in the Basement

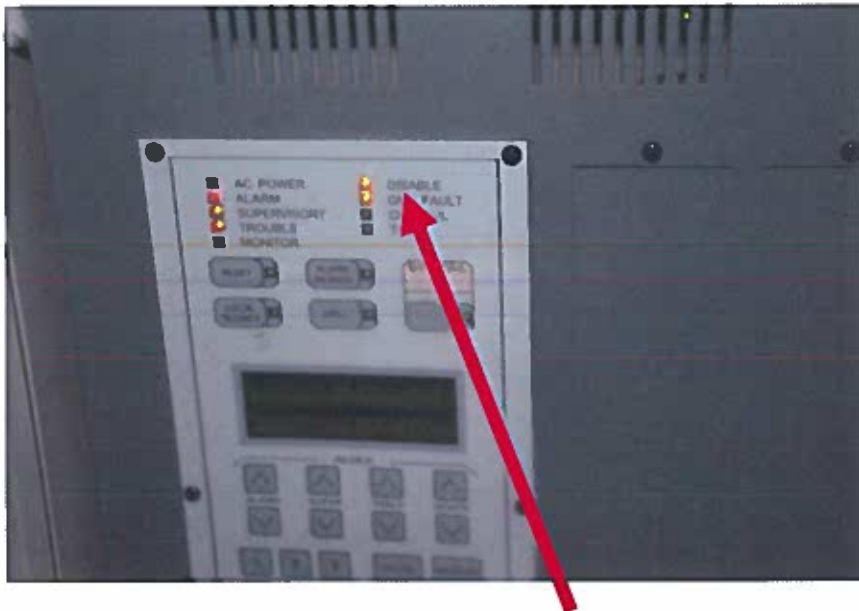
48. The fire alarm system was located in the basement. On the panel, the light labeled “Disable” was illuminated and the system was energized as of Thursday September 19, 2018. On that date, it was decided by the DCFD to leave the panel in place in order for it to be examined by representatives and forensic experts from the insurance industry. When investigators returned to the basement on September 23, the panel was no longer energized.

Alarm Panel with Disable Light Illuminated

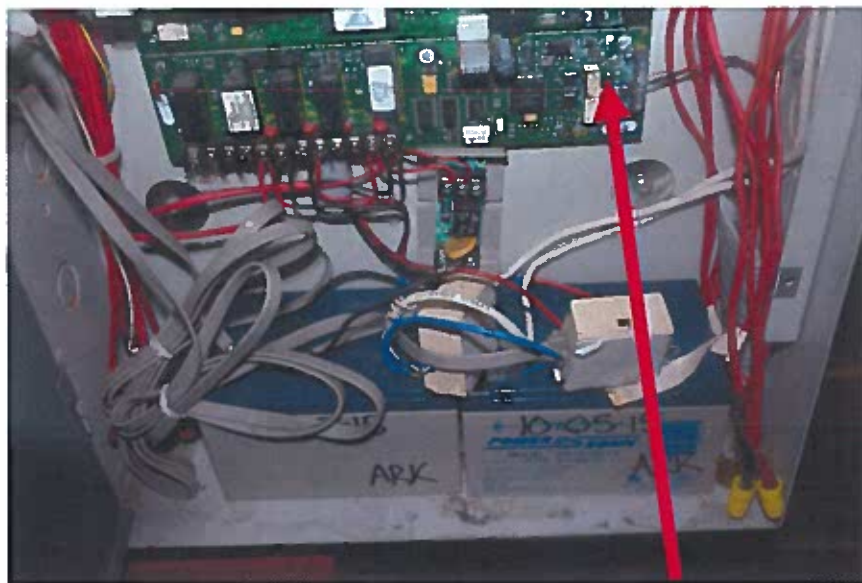
49. The inside of the panel revealed there was damage to a circuit of the panel. It was unclear whether this damage was caused by this event or pre-existed the fire event.

Blown Out Circuit inside the Fire Alarm Panel

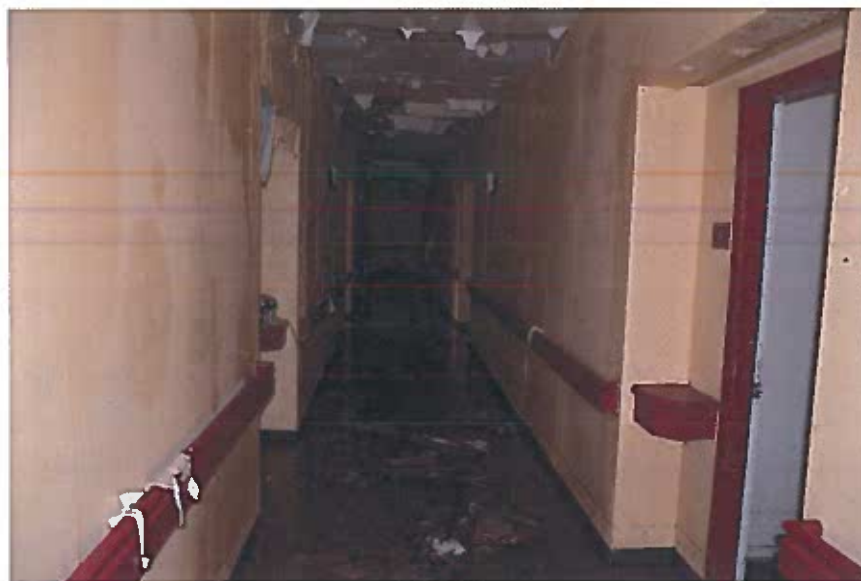
50. First Floor – This floor sustained no direct fire damage from this event. There was a significant amount of water on the floors and three areas of collapse along the inner rim of the building. These areas of collapse were along Side A, Side B and in the “CD” corner. In each area of collapse, investigators identified roofing material and portions of each of the floors above.

Water Damage on the First Floor

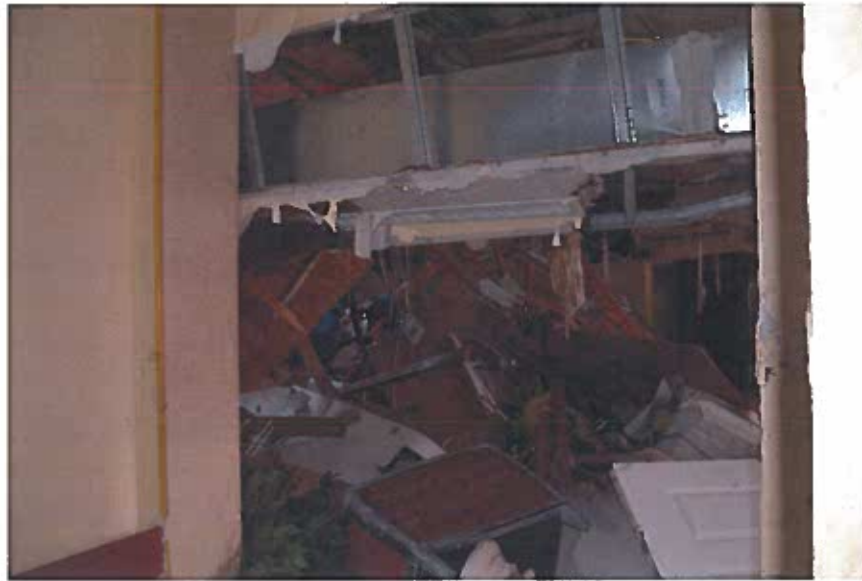
First Floor Collapse

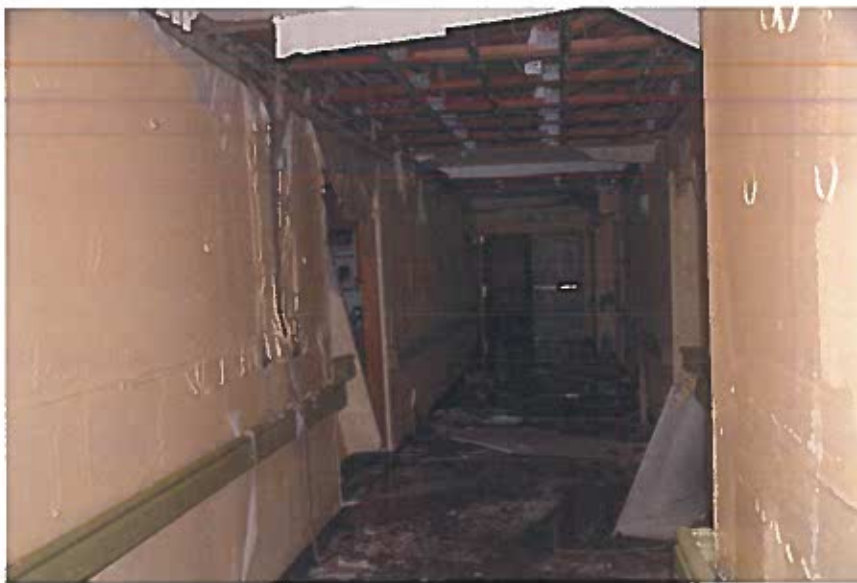
51. On September 20, 2018, the first floor was the only floor in which investigators were able to walk through each corridor, with the exception of the “CD” corner where it was unsafe to do so.
52. The lack of any direct fire damage is consistent with the fire not originating on the first floor.
53. Second Floor – The second floor damage was similar to that of the first with three areas of collapse and a large quantity of water on the floor. On September 20, 2018, investigators’ attempt to conduct a walk-through of this floor was unsuccessful due to concerns of further collapse and the softening of the hallway floors from the large amount of water on them.

Collapse and Water Damage on the Second Floor

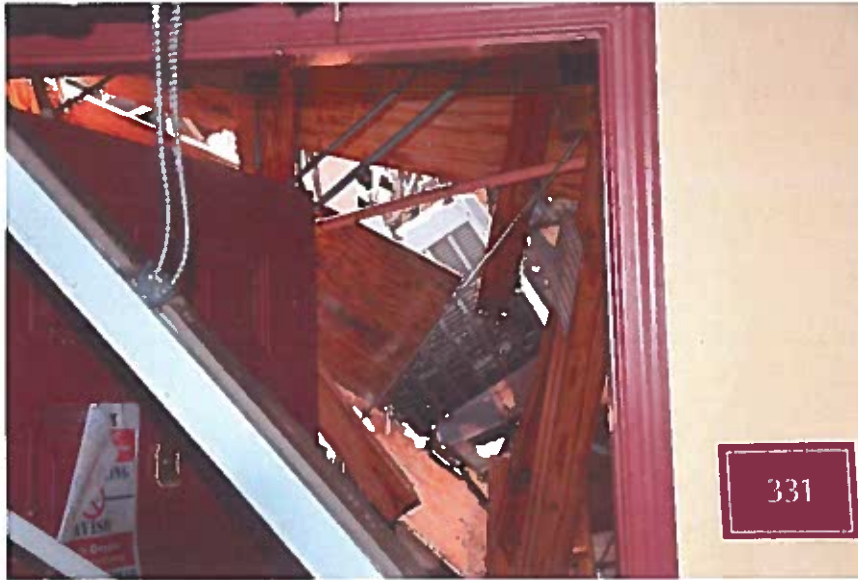
55. Third Floor – There was no direct fire damage on the third floor. The amount of water on the floor from fire suppression activities above was substantial. Investigators' attempts to walk this floor were unsuccessful and unsafe due to the excessive softening of the floors.
56. Collapse was present on this floor as well. Investigators were able to photograph inside Apartment 331, which sat directly below Apartment 431.

Collapse Down Through Apartment 331

58. The lack of any direct fire damage is consistent with the fire not originating on the third floor. The collapse down through Apartment 331 was the most damaged area of the floor and consistent with witness observations that the fire originated in the cockloft directly above this area. It should be noted that the collapse was caused by the large amount of water put into the building at this point rather than the collapse being caused by the fire itself.

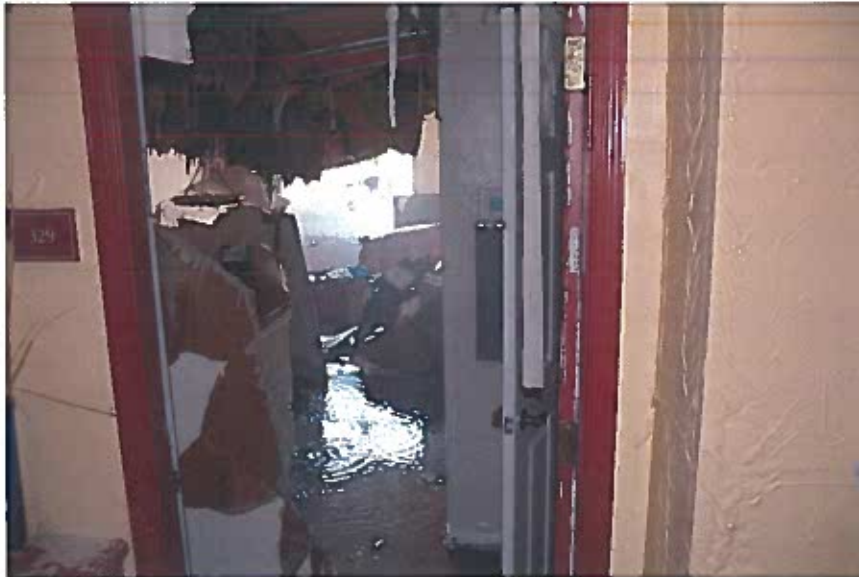
57. The neighboring Apartment 329 had some minor collapsing but significantly less than that of Apartment 331.

Collapse Down in Apartment 329

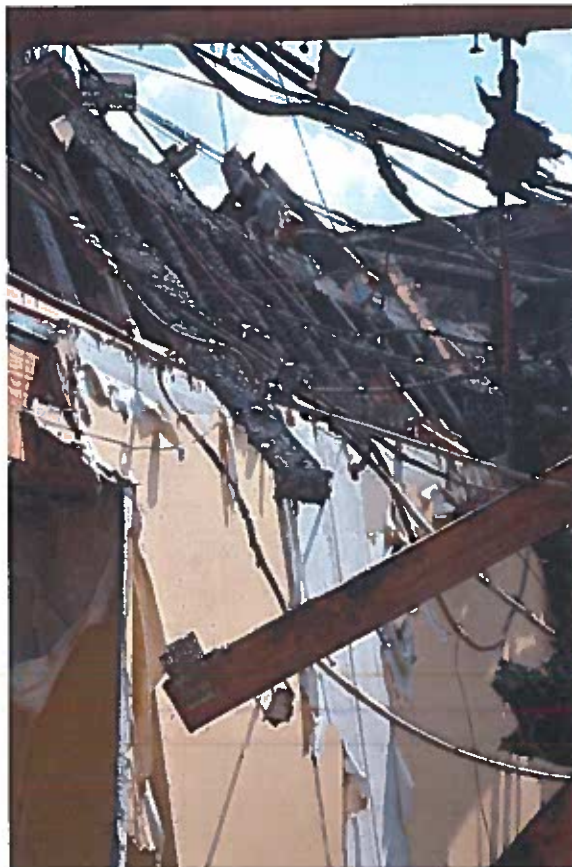
59. Fourth Floor – The fourth floor was damaged to the point that investigators could not make entry into the floor at all from the emergency staircase of Side A, as the risk of further collapse was too great. The direct fire damage observed was all above this floor. The lumber and wall covering of this floor were undamaged by fire. The damage to the lumber for the cockloft was badly charred and much of the asphalt roof covering this cockloft was consumed during the event. The most damage area of the cockloft was above Apartment 431.

Damage above Apartment 431

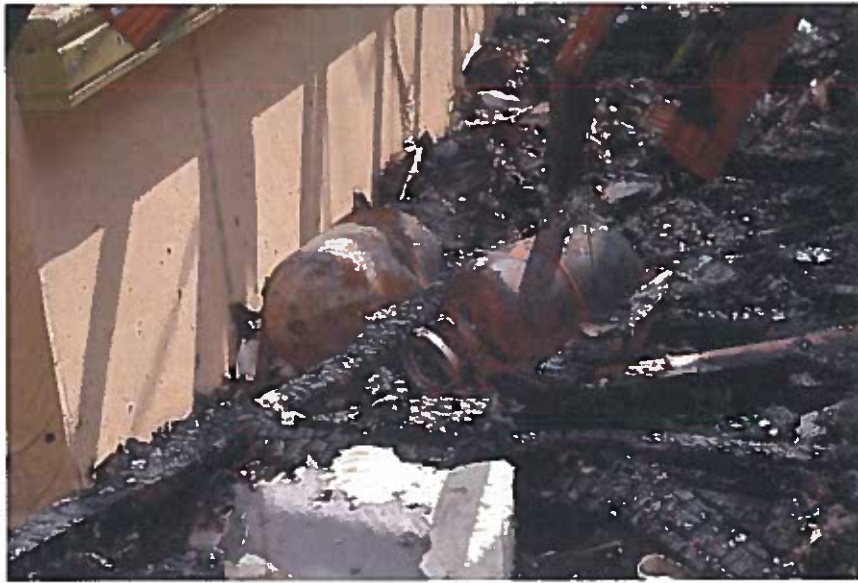
60. Firefighters stated that they believed they observed propane tanks on fire in this area of the building. Investigators uncovered no evidence of a propane tank in this area. A number of similar looking tanks used to hold Freon for air conditioning units were located. There is no evidence that a propane tank was involved in the ignition of this event.

Freon Tanks Damaged by Fire

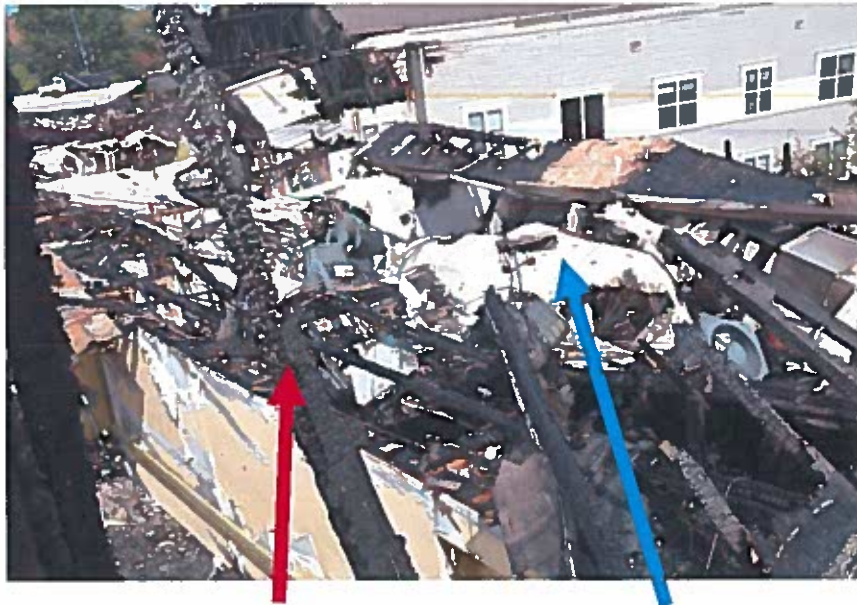
61. The damage observed on the fourth floor is consistent with a fire originating inside the cockloft above Apartment 431.
62. Attic Level – The damage to the Attic Level along Side A of the building was significant. The area around the emergency staircase had burned and collapsed to the fourth floor. The lumber for the cockloft was significantly charred and the roofing material was largely consumed. The roofing material on the inner flat section was in considerably better condition than the roof of the cockloft. This is consistent with the fire originating in the cockloft rather than on the flat section of roof.

Damage to the Cockloft vs. Damage to the Flat Section

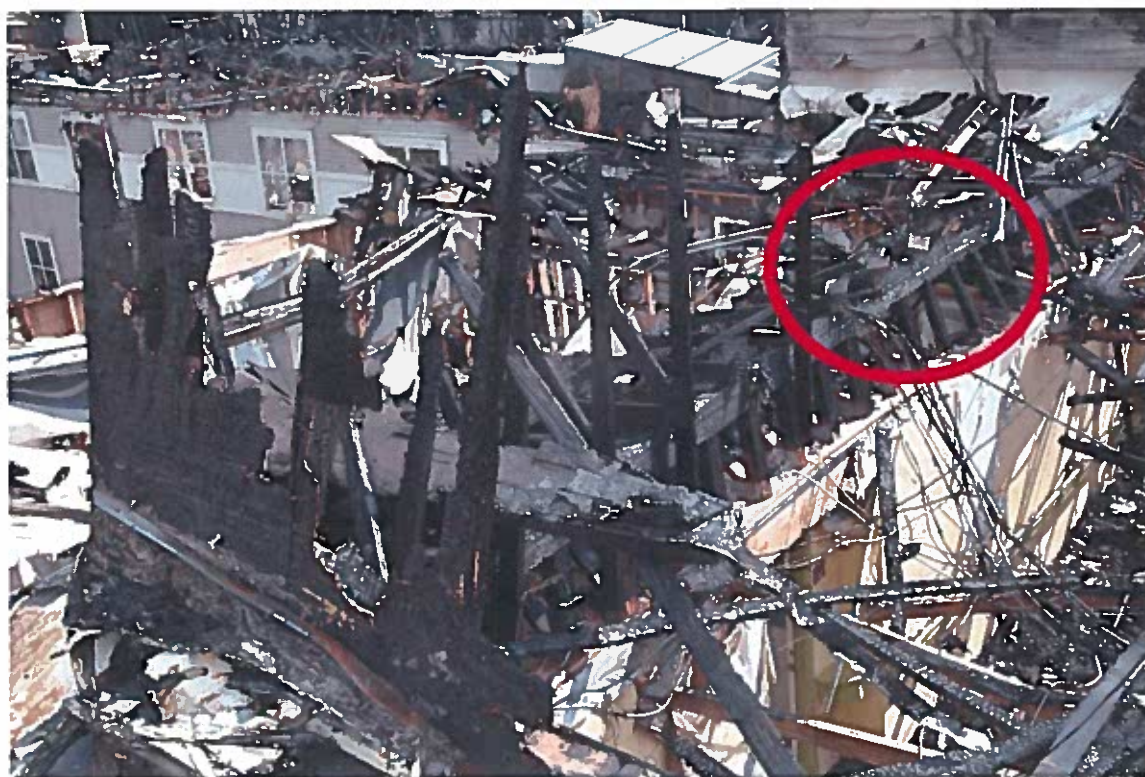
63. In the weeks after the fire, investigators, utilizing a crane were lowered into this area of the building and identified the area of origin as inside the cockloft directly above the kitchen for Apartment 431. Investigators

with the use of the crane removed Air Conditioning Compressors, electrical wiring, examined a bathroom ceiling fan, and light fixtures. These items were functioning as designed and did not cause this fire.

Area of Origin in the Cockloft above the Kitchen for Apartment 431

76. The area of origin of this fire is inside the cockloft directly above the kitchen for unit 431. Utilities for the building in that area have been examined. These include the electrical wiring, air conditioning units and its wiring, a bathroom exhaust fan, and wiring for various light fixtures for Apartment 431. Examination of these items revealed that they were in working order and did not cause this event.

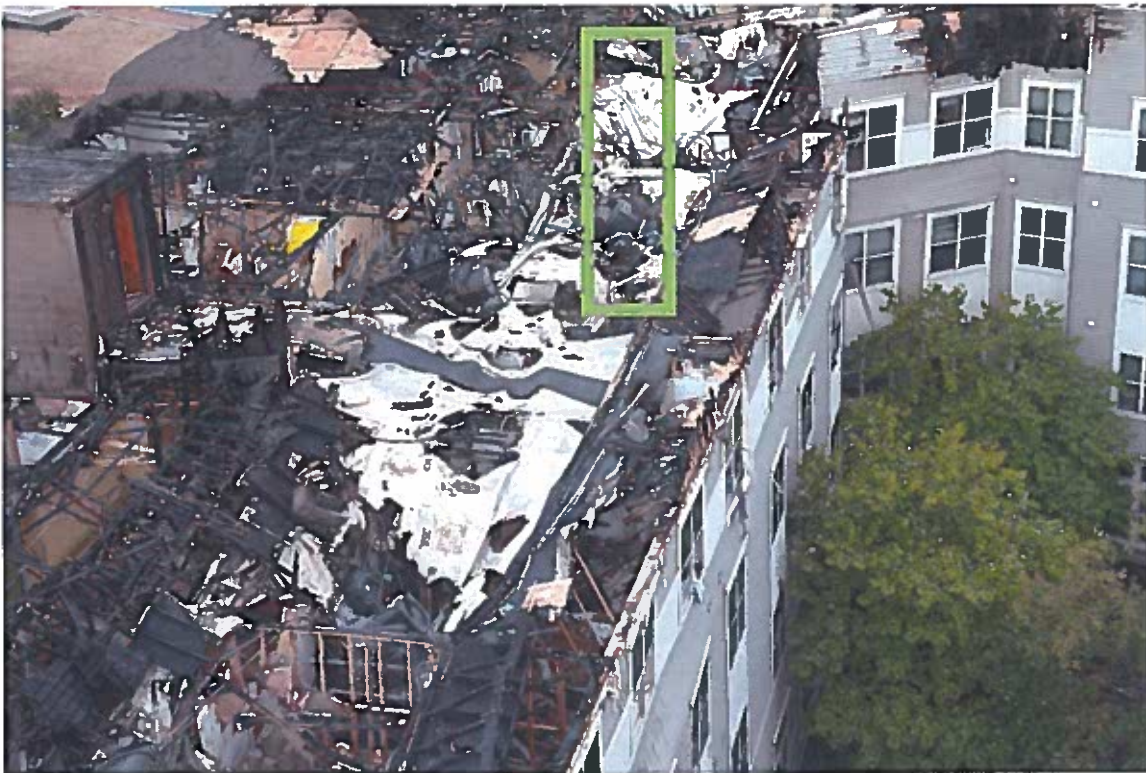
64. First arriving firefighters reported a garden hose pulled near where the fire originated. Investigators located a green garden hose extended toward the area of origin. The hose appears to have been pulled back towards its source as portions of the building collapsed. This is evidence that an unknown individual attempted to extinguish the fire in its early stages.

Garden Hose Pulled Towards Area of Origin

82. Investigators also located a garden hose used by maintenance to clean the air conditioning units on the roof. This garden hose was running and pulled as close to the area of origin as it would reach. This is clear evidence that there was some attempt by an unknown individual to fight the fire in its early stages.
